# Hollingdean Waste

**Contract:** South Downs Integrated Contract

**Incident Detail:** Date: 25/08/2019  
Time: 22:49  
Location where incident occurred: **Hollingdean Waste Transfer Station**

**Executive Summary [Please note this report is still pending the receipt of the BHCC Investigation Report]**

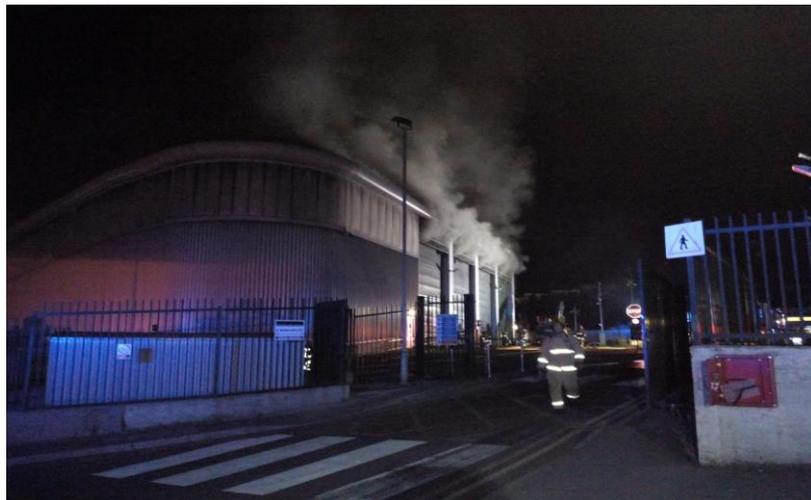
*Figure 1. Scene shortly after arrival on site*

As identified from CCTV, at approximately 22:16 on Sunday 25th August 2019 a fire started on the lower level of the WTS in the area where the streets / bulky waste is tipped. At 22:49 the fire alarm activated and the ADT Alarm Receiving Centre began calling keyholders. East Sussex Fire & Rescue Service were called to site by the Alarm Receiving Centre and arrived at 23:00. The Site Manager arrived at 23:18, see Figure 1, at which point the Fire Service had already gained access to site.

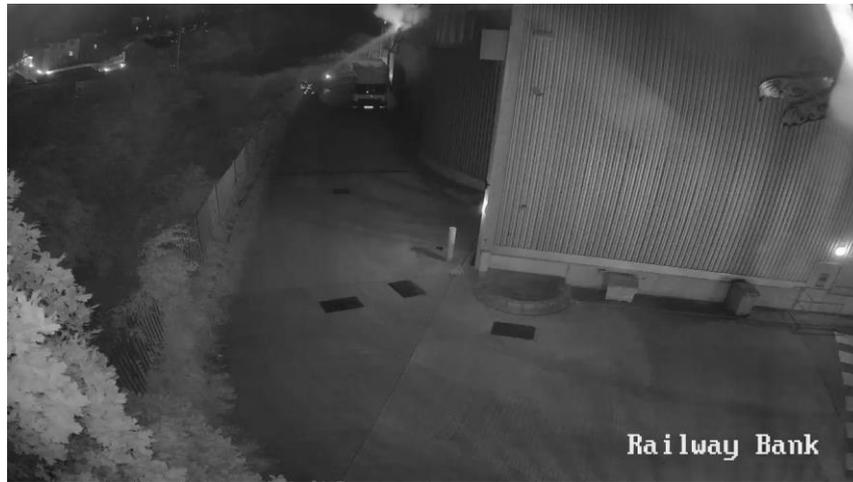
*Figure 2. Water applied through hole in Danpalon panelled section (22:15)*

At this point a fire crew had been deployed around the railway side of the WTS to fight the fire through a hole in the melting Danpalon panelling above the bulky waste bay, see Figure 2. An access hole had been cut in door 4 for hoses to be put through to fight the fire from outside the building. However the fridges and WEEE behind door 4 prevented this. A hole was then cut in door 3.

Access was available through the hole in the melted Danpalon panelling to apply water on to the top of the bulky bay.

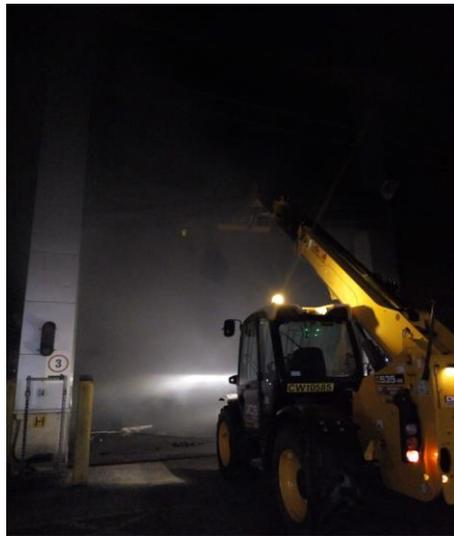
Figure 3. Telehandler used to open door 3 for smoke ventilation

To aid in clearing smoke from the building the Incident Commander requested that one of the upper level vehicle doors be lifted. This was achieved at approximately 02:40 using a Telehandler to force up and then support the door on its boom, where it remained for several hours, see Figure 3.

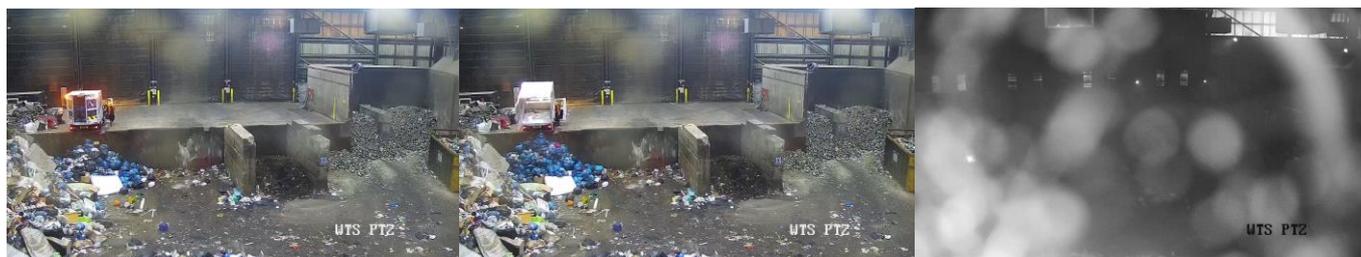
Figure 4. showing before last tip (21:19), after last tip (21:20), point of ignition (22:16)

Each of these tips has been reviewed on CCTV, see Figure 4. The precise location where each waste pile landed, cross referenced with the later images showing the ignition point, lead to a very high probability that the fire originated in the very last load tipped, at 21:20. The prior load was tipped in a different location, and the loads before were tipped significantly earlier on.

At the point of tipping, no smoke or flame(s) can be seen along the tipping wall. Immediately after the load was tipped, at 21:21, the Traffic Controller turned off the building lights and left the building for the evening no smoke or flames were visible.. From this point on the cameras are operating in darkness, however it can be shown from later footage that smoke and flame would have been visible on three cameras. From the point

of tipping at 21:20 until the first visible hot spot at 22:16 there was no smoke or flame(s) visible on these cameras.

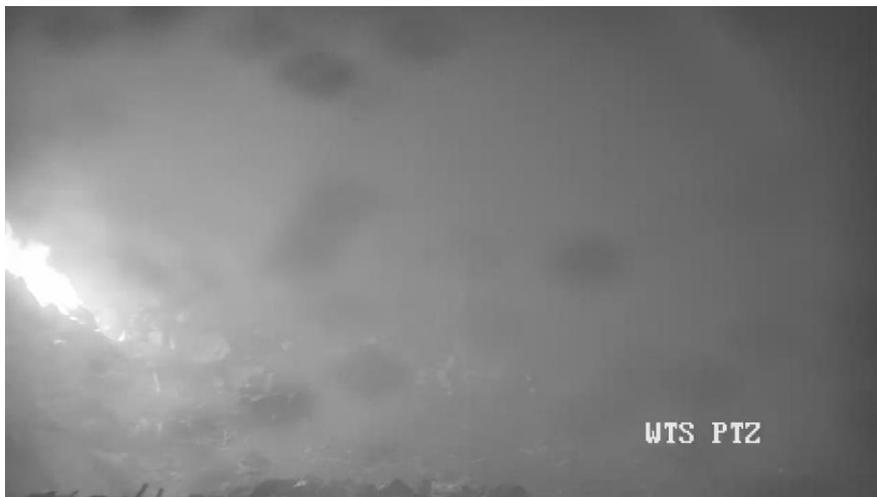
*CCTV image taken at 22:48 (alarm activation point)*

Fire detection within the WTS comprises linear heat cable, also known as heat tape. This runs along the roof spans a long way from the stored waste. When the cable reaches 50 degrees Celsius the alarm is activated. The alarm is connected to the ADT Alarm Receiving Centre.

ADT called the MRF Manager as the first keyholder on the list at 22:49 so the fire alarm activation would have been less than one minute prior. This gives the time between the first visible heat / flame at 22:16 and activation as 33 minutes - by which time it appears that the fire was well established.

- Review the fire detection system to establish if further enhancements can be added to bolster the system;
- Review the ability for Newhaven ERF to accept waste at the weekend and amend planning as necessary.

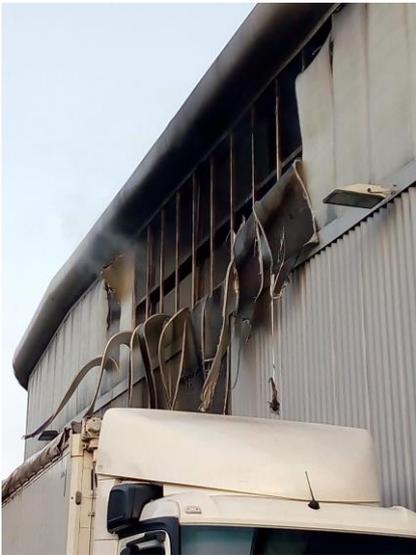
Figure 6. *Damage to Danpalon panels*

The fire caused damage to an area of Danpalon wall panelling above the bulky waste bay, and damage to internal wiring which had rendered some systems inoperable such as vehicle access doors, odour control systems and internal lighting.

Contractors were then called to assess and begin effecting repairs to damaged systems. DJW Electrical Contractors attended site, checked all fixed wiring and disconnected any circuits that failed resistance testing, and will follow up with a quote to repair the cabling and lighting. Calor Gas attended site to remove some of the gas bottles that had been removed from the facility by the Fire Service. Avco attended site on Wednesday 28th August to remove damaged Danpalon panels hanging from the building, see Figure 6. They also assessed the damaged rainwater downpipes and concluded that there was significant work required to reinstate them. The damaged Danaplon panels were replaced with temporary panels on Friday 30th August.
