Structural Engineer's Report
for
Dudeney Lodge, Brighton
Brighton & Hove City Council

Issue Number 01
1 July 2019

- I.1 PE Report Reference : STR/IPR/IPG/190215/17-2/R007 – Issue 01
- I.2 Client : Brighton & Hove City Council
- I.2.1 Address : Housing Centre
Unit 1 Fairway Trading Estate
Eastergate Road
Moulsecoomb
Brighton
BN2 4QL
- I.2.2 Telephone Number : [REDACTED]
- I.3 Inspected Property : Dudeney Lodge
Upper Hollingdean Road
Brighton
BN1 7GT
- I.4 Occupier : Various tenants and leaseholders
- I.5 Inspecting Engineer/Surveyor : [REDACTED]
- I.6 Instruction
- I.6.1 Mode : Purchase Order
- I.6.2 Reference : BHC0608879/0
- I.6.3 Instructed by : Geof Gage
- I.6.4 On behalf of : Brighton & Hove City Council
- I.7 Brief

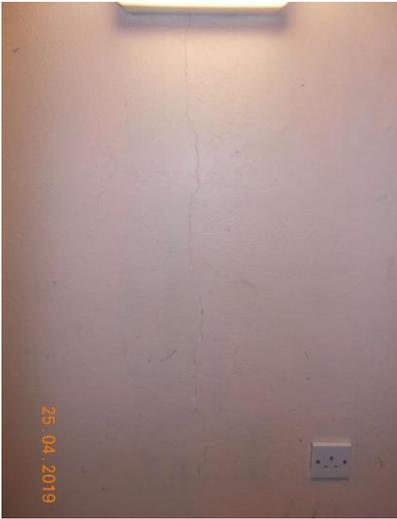
Photo No. INT-36

Location	Building Element	Element Description	Condition / Defect	Recommended Works	Photo Number	Rec Year Of Work
Flat ■■■ Bathroom	Internal Ceiling	Artex on Precast Reinforced Concrete Slab	Very slight crack in ceiling finish at joint in floor slab. The damage is considered to be due to slight thermal expansions and contractions between the slab sections. This is not considered to be of structural significance. The tenant reported that the crack had been present for approximately 7 or 8 years and never repaired during that time.	Rake out crack and re-artex flush with the existing and redecorate.	INT-5/6	2020
Hallway and Stairs Various Floors	Internal face of wall	Precast Concrete Wall	Typical hairline to very slight vertical cracks at joints of precast concrete wall panels at various floor levels. The damage is considered to be due to slight thermal expansions and contractions between the wall sections. This damage is not considered structurally significant.	Visually monitor as part of future routine inspections.	INT-36	2024

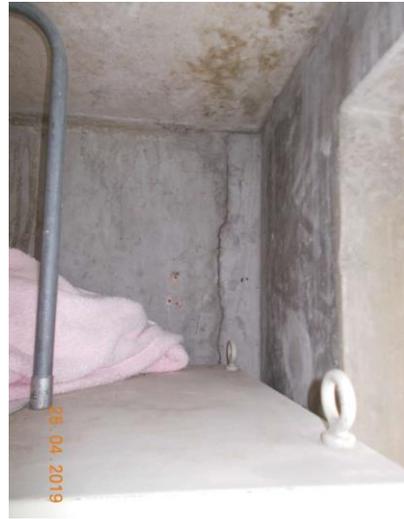
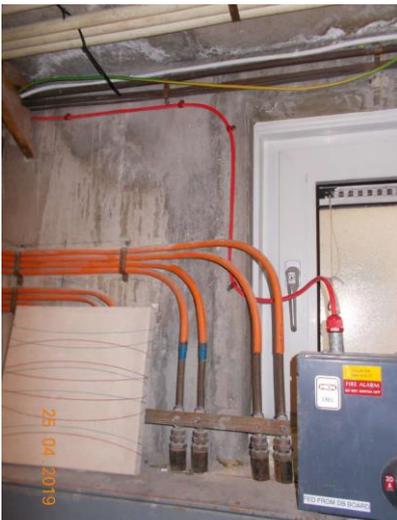
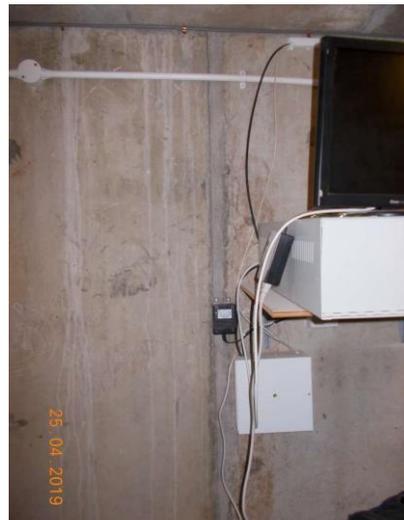
Electricity Intake Room	Internal face of wall	Precast Concrete Wall	Slight vertical crack at joints of precast concrete wall panels in South East corner of room and along the West wall and East wall. The damage is considered to be due to slight thermal expansions and contractions between the wall sections. This damage is not considered structurally significant.	Visually monitor as part of future routine inspections.	INT-38 / INT-39 / INT-40	2024

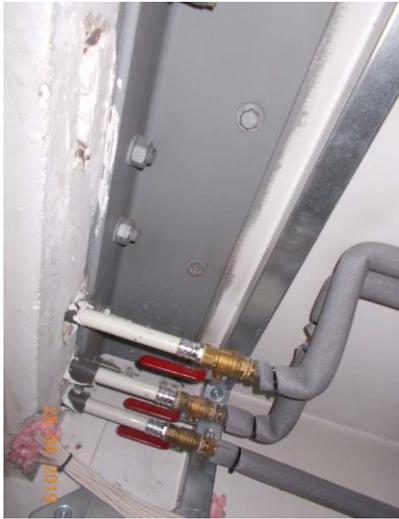
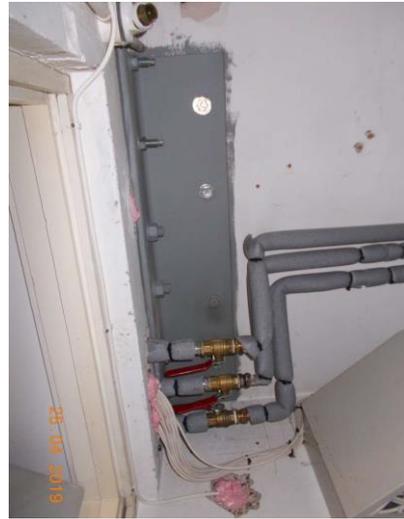
Location	Building Element	Element Description	Condition / Defect	Recommended Works	Photo Number	Rec Year Of Work
Electricity Intake Room	Internal Ceiling	Precast Reinforced Concrete Slab	Very slight crack in ceiling at joint in floor slab. The damage is considered to be due to slight thermal expansions and contractions between the slab sections. This is not considered to be of structural significance.	Visually monitor as part of future routine inspections.	INT-41	2024
Refuse Room	Internal Ceiling	Precast Reinforced Concrete Slab	Various very slight cracks in ceiling at joints between floor slabs. The damage is considered to be due to slight thermal expansions and contractions between the slab sections. This is not considered to be of structural significance.	Visually monitor as part of future routine inspections.	INT-47	2024
Dry Risers and Risers	Internal Ceiling and Walls	Precast Concrete Walls and Slab	It was observed that within all upper floor Risers and Dry Risers either side of the central Hallways, that steel angle plates had been bolted to the walls between the corridor and risers and the adjacent floor slabs, presumably to act as additional bracing or support for the slab edges at these particular locations.	There did not appear to be any sign of distress in the original construction in these locations or defects with the new steel angles. It would be prudent to review if there are any additional archive records available to ascertain the purpose of these steel angles. In addition, these should be visually monitored as part of future routine inspections.	INT-53/61	2024

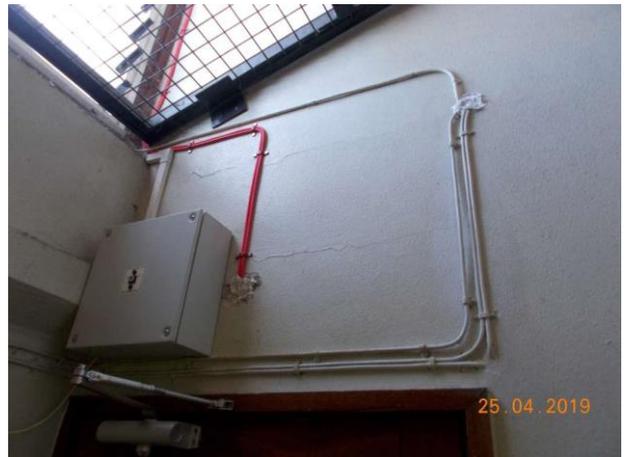
Photo No. INT-69

There was evidence of 1 no. internal patch repair to floor/wall junction at the 6th floor level in the Stairs, which might suggest that investigation and possibly strengthening works may have been carried out at the joint, possibly following the Ronan Point disaster. However, as this location was localised to 1 no. area, this might suggest that only investigation works were undertaken rather than strengthening works, which might otherwise be evident with patch repairs at all floor levels. However, evidence of other areas of investigations or strengthening works may now be hidden behind decorative finishes.

Location	Building Element	Element Description	Condition / Defect	Recommended Works	Photo Number	Rec Year Of Work
Stairs, 6 th floor level	Walls	Precast Concrete Wall	Patch repair observed at the level of the 6 th floor slab. This could be a location of previous investigations or remedial strengthening repairs.	There did not appear to be any sign of distress in the repair. It would be prudent to review if there are any additional archive records available to ascertain the details of the repair and any possible investigation works undertaken. In addition, these should be visually monitored as part of future routine inspections.	INT-62	2020
Stairs, 14 th floor level	Walls	Precast Concrete Wall	Hairline horizontal crack at joint between floor slab and wall panels. The damage is considered to be due to slight thermal expansions and contractions between the slab sections. This is not considered to be of structural significance.	Visually monitor as part of future routine inspections.	INT-69	2024

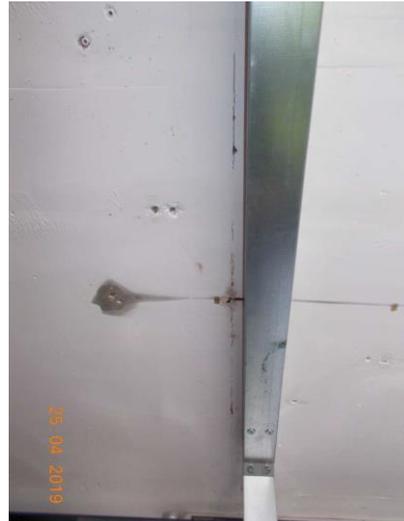
Photo No. INT-83

Roof Lift Plant Room	Walls	Precast Concrete Wall	Hairline horizontal crack at joint between floor slab and wall panels. The damage is considered to be due to slight thermal expansions and contractions between the slab sections. This is not considered to be of structural significance.	Visually monitor as part of future routine inspections.	INT-82	2024
Roof Lift Plant Room	Internal Ceiling	Precast Reinforced Concrete Slab	Very slight crack in ceiling at joint in roof slab. The damage is considered to be due to slight thermal expansions and contractions between the slab sections. This is not considered to be of structural significance.	Visually monitor as part of future routine inspections.	INT-83	2024

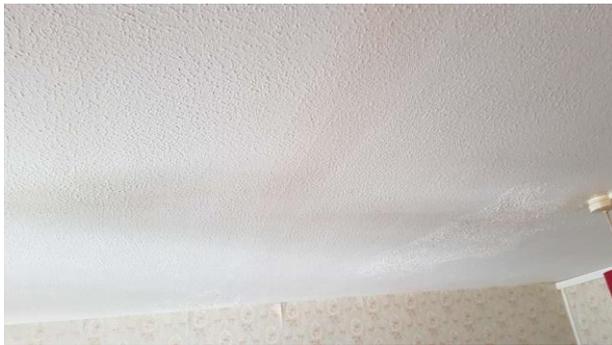
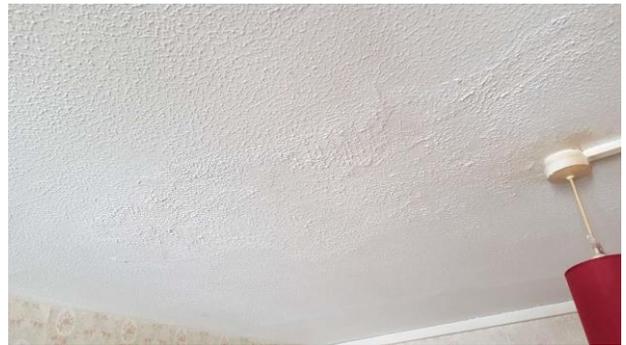
Location	Building Element	Element Description	Condition / Defect	Recommended Works	Photo Number	Rec Year Of Work
Flat ■ Living Room	Internal Ceiling	Artex on Precast Reinforced Concrete Slab	<p>The tenant was concerned that there may be damage to the concrete floor slabs beneath a previous artex repair. He reported that at the time of the artex repair some years ago, there was a visible crack in the slab, the full width of the room. It could be that this was a joint in the slab, although there is a visible joint between the slabs just to the East of the artex repair, so it may be unlikely to be this. However, if there was structurally significant movement that caused cracking to the slab, we would expect to be able to observe this through the artex finish. There was no current structurally significant cracking within the artex finish, only a hairline crack at the adjacent slab joint.</p> <p>However, this damage is considered to be due to slight thermal expansions and contractions between the slab sections and is not considered to be of structural significance.</p>	Visually monitor as part of future routine inspections.	INT-86/87	2024

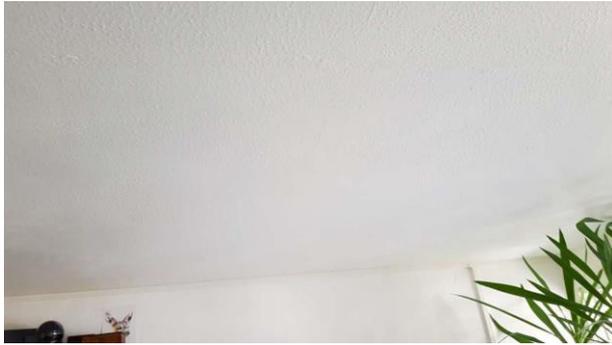
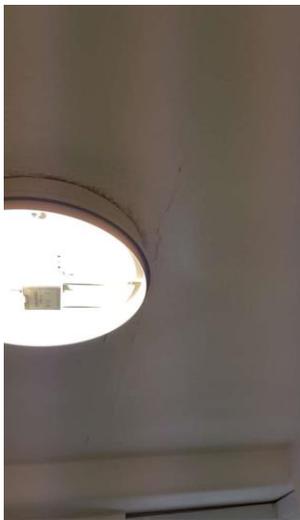
Location	Building Element	Element Description	Condition / Defect	Recommended Works	Photo Number	Rec Year Of Work
Flat ■ Bedroom	Walls	Precast Concrete Wall	Slight vertical crack/gap at joints of precast concrete wall panels in South East corner of room. The damage is considered to be due to slight thermal expansions and contractions between the wall sections. This damage is not considered structurally significant. The tenant reports that the gap was observed when wallpaper was removed. It has since been painted over without being filled.	Visually monitor as part of future routine inspections.	INT-90/91	2024
Flat ■ Bedroom and Bathroom	Internal Ceiling	Precast Reinforced Concrete Slab	Very slight cracks in ceiling at joints between floor slabs. The damage is considered to be due to slight thermal expansions and contractions between the slab sections. This is not considered to be of structural significance.	Visually monitor as part of future routine inspections.	INT-93/95	2024

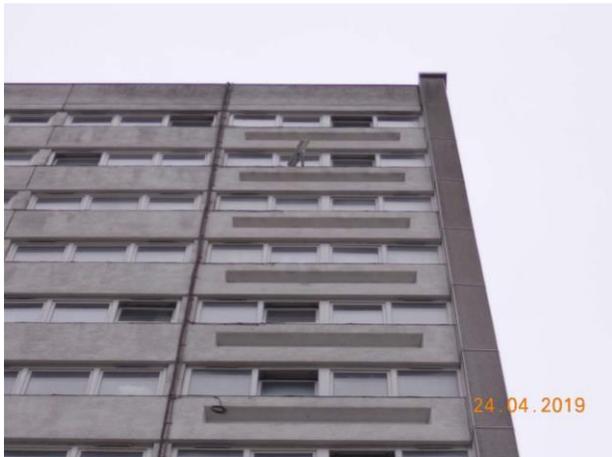
Photo No. EXT-13

External East Elevation, [REDACTED]	Walls	Pre-cast concrete non-loadbearing external panel below window	Possible slight localised corrosion of reinforcement bar below recess.	Visually monitor as part of future routine inspections.	EXT-13	2024

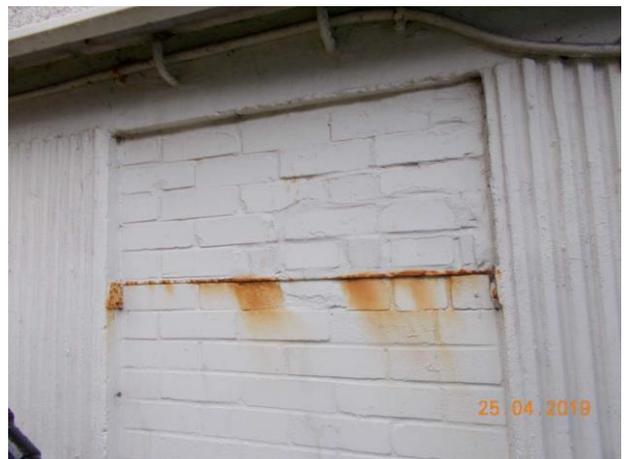
Photo No. EXT-34

Location	Building Element	Element Description	Condition / Defect	Recommended Works	Photo Number	Rec Year Of Work
External South Elevation, Ground Floor Level at South East corner of building	Walls	Pre-cast concrete loadbearing wall panels	Localised spalling visible to bottom of ground floor panel.	Visually monitor as part of future routine inspections.	EXT-32	2024
External South Elevation, Lower Ground Floor Level	Walls	Brickwork infill to opening at lower ground floor level	Corroding steel element within brickwork infill within pre-cast concrete panel.	Arrange for access into the lower ground floor garage at this location, to inspect the wall internally. Confirm function of steel to allow appropriate remedial repairs to be specified.	EXT-34	2020
