Structural Engineer's Report
for
Heron Court, Brighton
Brighton & Hove City Council

Issue Number 01
25 June 2019

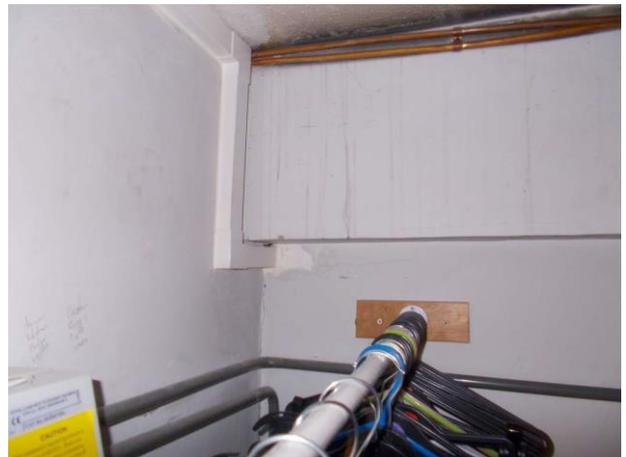
Photo No. 199

Flat ■ Wardrobe/ Coat Room	Internal Wall	Stud Wall	Very slight vertical and horizontal crack to wall. The damage is not considered structurally significant.	Visually monitor as part of future routine inspections.	199	2024
Flat ■ Bathroom	Internal Ceiling	Precast Reinforced Concrete Slab	Filled joint between precast concrete floor panels.	Visually monitor as part of future routine inspections.	200	2024
Flat ■ Bedroom	Internal Ceiling	Precast Reinforced Concrete Slab	Possible previous concrete repairs. No evidence of current spalling.	Visually monitor as part of future routine inspections.	201	2024

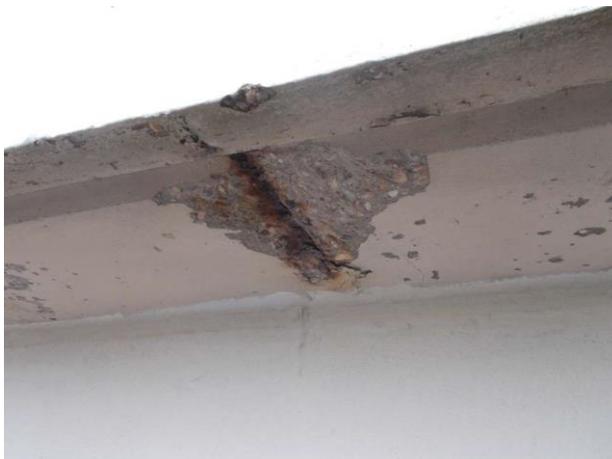
Photo No. 241

Roof	Soffit of Roof Overhang to Central Stairwell and Lift Shafts	Precast Reinforced Concrete	Various localised patches of exposed corroding reinforcement and spalling concrete to all elevations.	Break out surrounding concrete. Clean any corroded steel reinforcement back to bright metal and apply zinc rich paint followed by proprietary concrete repair in accordance with manufacturer's specification.	241	2020

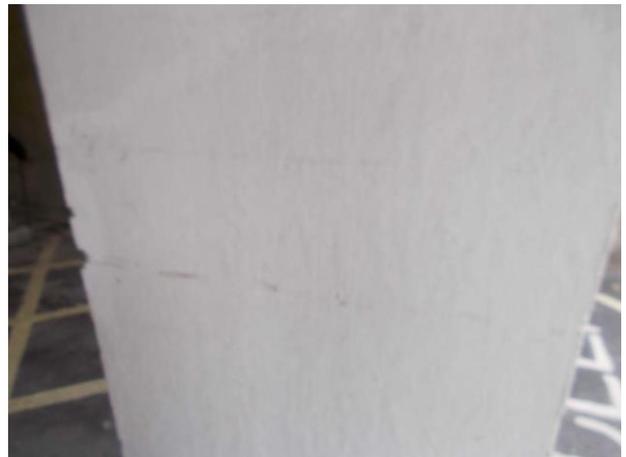
Photo No. 260

Location	Building Element	Element Description	Condition / Defect	Recommended Works	Photo Number	Rec Year Of Work
East External Elevation, [REDACTED] level column between [REDACTED]	Column	In-situ Concrete Column	Corrosion stain to bottom of column, suggesting localised corrosion to internal reinforcement.	Break out surrounding concrete. Clean any corroded steel reinforcement back to bright metal and apply zinc rich paint followed by proprietary concrete repair in accordance with manufacturer's specification.	258	2020
East External Elevation, [REDACTED] level column between [REDACTED]	Column	In-situ Concrete Column	Slight impact Damage. The damage is not considered structurally significant.	Visually monitor as part of future routine inspections.	259	2024
East External Elevation, [REDACTED] level column between [REDACTED]	Column	In-situ Concrete Column	Slight impact Damage. The damage is not considered structurally significant.	Visually monitor as part of future routine inspections.	260	2024

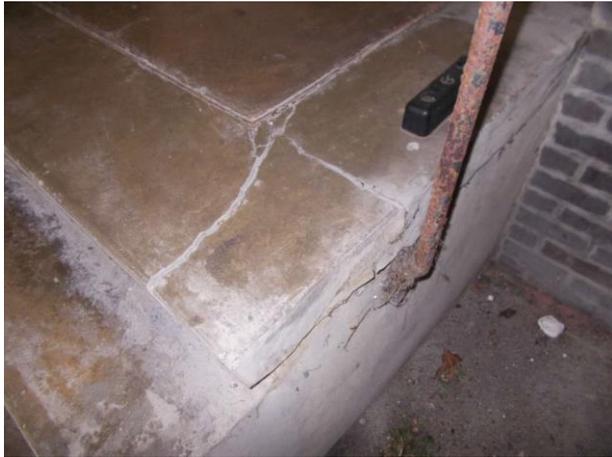
Photo No. 261

East External Elevation, Ground level	Entrance Staircase Landing	In-situ Concrete	Cracked concrete landing with loose section of concrete.	Break out loose concrete and apply proprietary concrete repair in accordance with manufacturer's specification.	261	2020

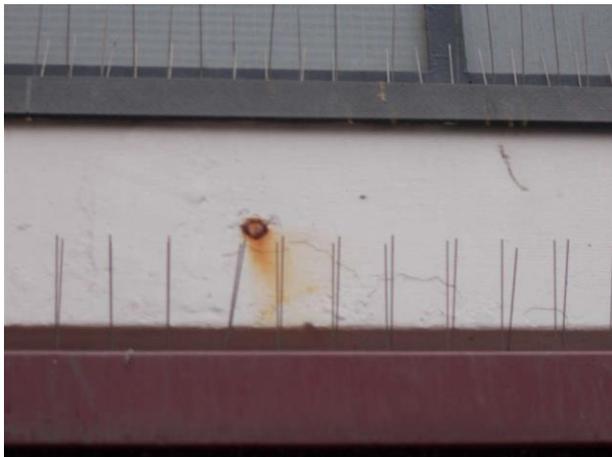
Photo No. 267

West External Elevation ■■■■■ balcony slab edge ■■■■■	Floor Slab	Precast Reinforced Concrete	Corrosion stain to slab edge, suggesting localised corrosion to internal reinforcement.	Break out surrounding concrete. Clean any corroded steel reinforcement back to bright metal and apply zinc rich paint followed by proprietary concrete repair in accordance with manufacturer's specification.	267	2020

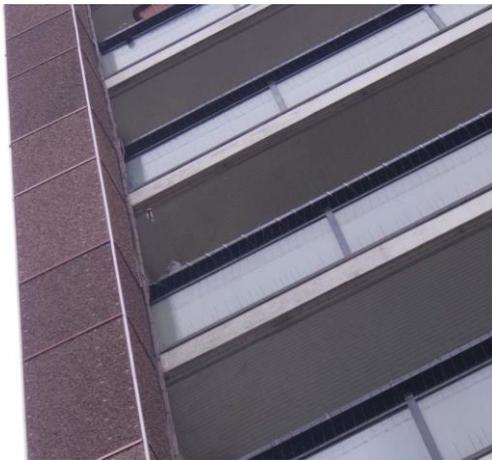
Photo No. 273

West External Elevation ■■■ balcony soffit, ■■■	Floor Slab	Precast Reinforced Concrete	Possible spalling to soffit – unclear when viewed from ground level through netting.	Inspect more closely and if repair required, break out surrounding concrete. Clean any corroded steel reinforcement back to bright metal and apply zinc rich paint followed by proprietary concrete repair in accordance with manufacturer's specification.	273	2020

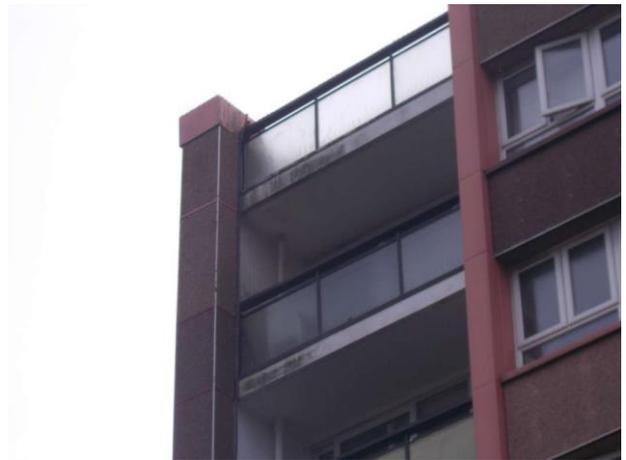
Photo No. 274

Location	Building Element	Element Description	Condition / Defect	Recommended Works	Photo Number	Rec Year Of Work
East External Elevation ■■■■■ balcony soffit, ■■■■■	Floor Slab	Precast Reinforced Concrete	Possible spalling to soffit – unclear when viewed from ground level through netting.	Inspect more closely and if repair required, break out surrounding concrete. Clean any corroded steel reinforcement back to bright metal and apply zinc rich paint followed by proprietary concrete repair in accordance with manufacturer's specification.	274	2020
