Structural Engineer's Report  
for  
Kingfisher Court, Brighton  
Brighton & Hove City Council

Issue Number 01  
4 July 2019

I.1	PE Report Reference	:	STR/IPR/IPG/190215/17-2/R004 – Issue 01
I.2	Client	:	Brighton & Hove City Council
I.2.1	Address	:	Housing Centre Unit 1 Fairway Trading Estate Eastergate Road Moulsecoomb Brighton BN2 4QL
I.2.2	Telephone Number	:	██████████
I.3	Inspected Property	:	Kingfisher Court Swanborough Place Brighton BN2 5FX
I.4	Occupier	:	Various tenants and leaseholders
I.5	Inspecting Engineer/Surveyor	:	██████████
I.6	Instruction	:	
I.6.1	Mode	:	Purchase Order
I.6.2	Reference	:	BHC0608879/0
I.6.3	Instructed by	:	Geof Gage
I.6.4	On behalf of	:	Brighton & Hove City Council
I.7	Brief	:

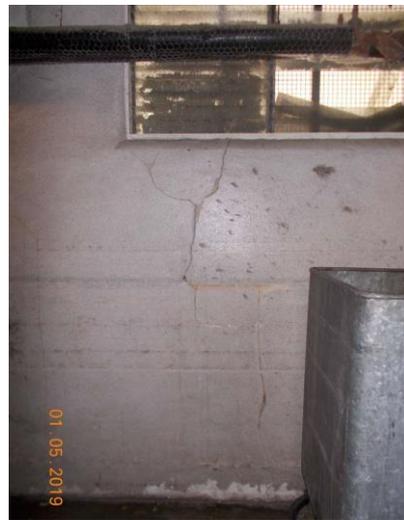
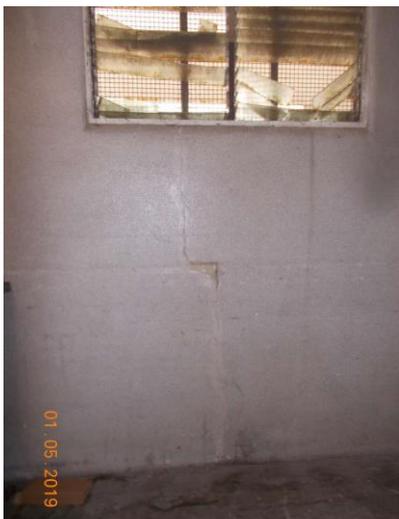
Bin Store ground floor	Walls	Brick and Block masonry walls with painted plaster finish	Typical very slight diagonal and vertical cracks. The damage is considered to be due to thermal expansions and contractions in the internal blockwork leaf, which do not have movement joints. This is not considered to be of structural significance at present. There is no obvious cracking to the external brickwork leaf at present.	Visually monitor as part of future routine inspections.	INT-290 / INT-291	2024

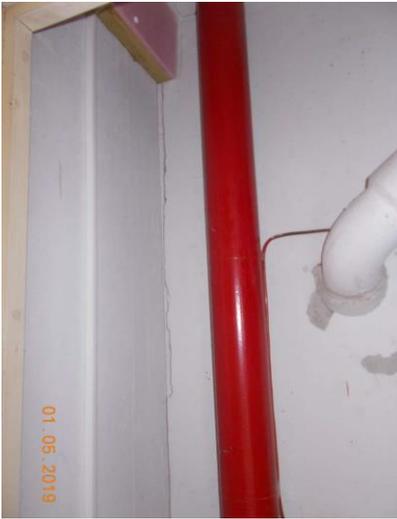
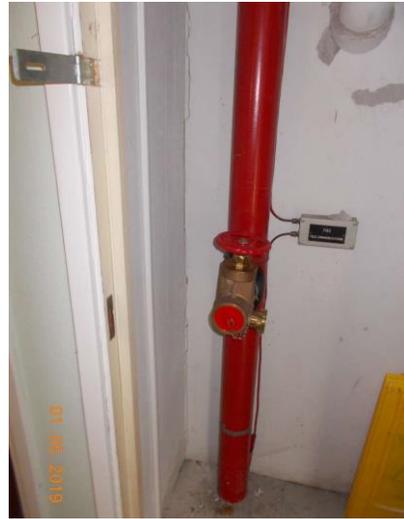
Hallway Dry Riser, Various Floors, South West Corner	Walls	Precast Concrete Wall	Typical vertical crack at joint of wall panels. This damage is not considered structurally significant. However, it could be a passage for smoke in the event of a fire, which may hinder the fire service whilst using the dry riser.	It would be prudent to seal these very slight gaps between the panels in the Dry Riser at all levels up through the building, with a proprietary Intumescent Sealant.	INT-302 / INT-303	2019

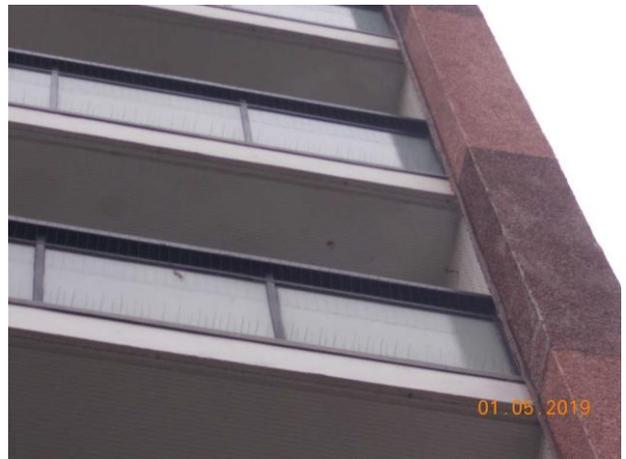
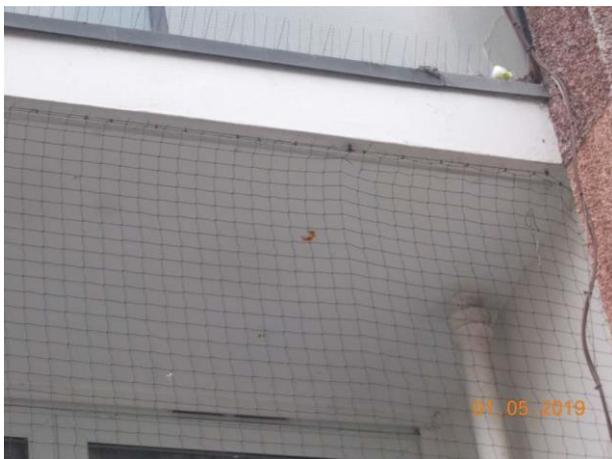
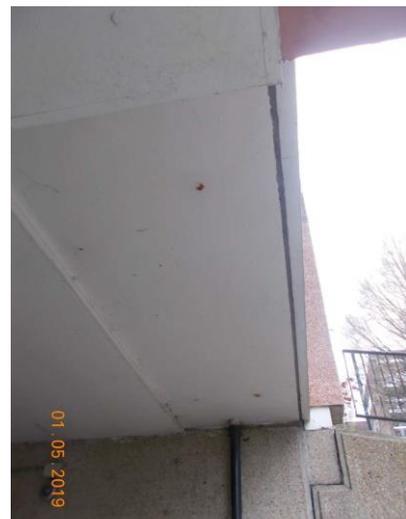
East and West Elevations	Walls	Possible in-situ concrete wall at first floor level.	There is evidence of previous patch repairs to the ins-in-situ concrete. These all appear in satisfactory condition at present.	Visually monitor as part of future routine inspections.	EXT-283 / EXT-286	2024
Roof	Roof Drainage	Drainage Outlets at Building Perimeter	Various drainage outlets in the building corners are blocked with vegetation and debris to varying degrees.	It would be prudent to clear out the debris as part of routine maintenance to ensure that water does not build up and pond on the roof.	EXT-316	2019
East Elevation, [REDACTED] Soffit [REDACTED] [REDACTED] Floor slabs of balconies	Floor	Reinforced Precast Concrete Floor	Localised spot corrosion stain and possible concrete spalling.	Locally break out surrounding concrete. Clean any corroded steel reinforcement back to bright metal and apply zinc rich paint followed by proprietary concrete repair in accordance with manufacturer's specification.	EXT-327 / EXT-328 / EXT-329	2020

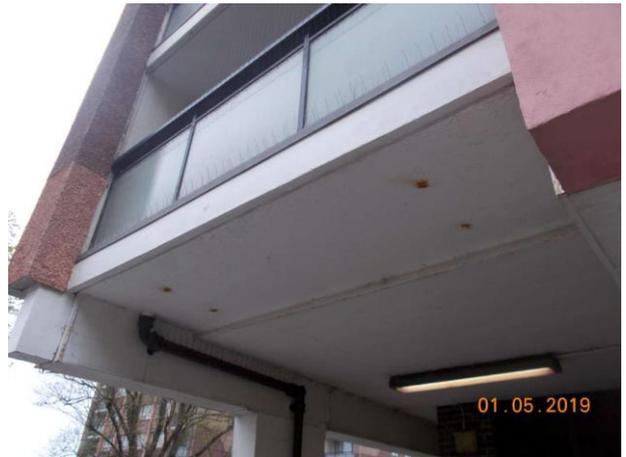
**Photo No. EXT-336**

Location	Building Element	Element Description	Condition / Defect	Recommended Works	Photo Number	Rec Year Of Work
East Elevation, [REDACTED]	Walls	Precast Concrete Wall	Localised spot corrosion stains to bottom edge of various visible original pre-cast concrete panels. This is not considered to be structurally significant at the present time.	It would be prudent to carry out further closer inspection and possible intrusive investigations of this area of the building externally as part of the general investigation work recommended within section 6.0 of this report.	EXT-334	2020
East Elevation, [REDACTED] Soffit of [REDACTED] slab of balcony	Floor	Reinforced Precast Concrete Floor	Localised spot corrosion stains. These appear to be in a regular pattern, suggesting that they may be from old fixings still embedded in the slab.	It would be prudent to carry out further closer inspection and possible intrusive investigations of this area of the building externally as part of the general investigation work recommended within section 6.0 of this report.	EXT-336	2020

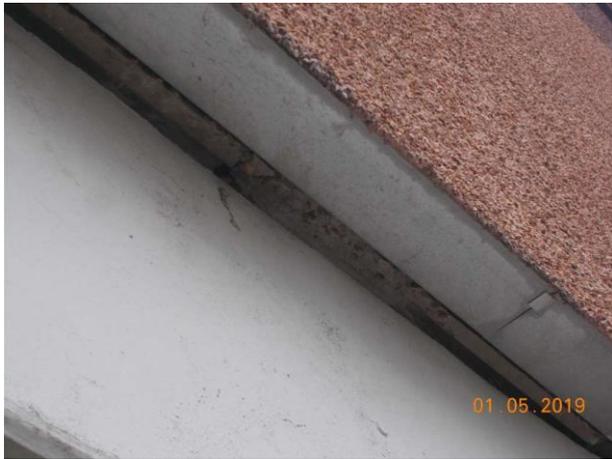
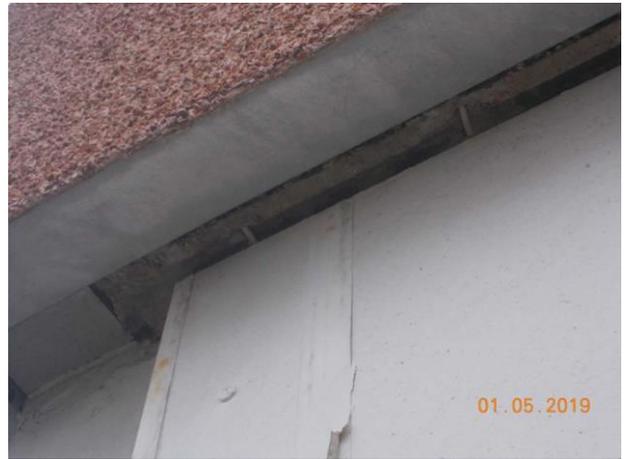
South Elevation, Various Locations	Walls	Precast Concrete Wall	Localised impact damage and exposed reinforcement bars to bottom edge of various visible original pre-cast concrete wall panels. It appears that the exposed bars have been painted. This is not considered to be structurally significant at the present time.	Visually monitor as part of future routine inspections.	EXT-340 / EXT-341	2024
