Structural Engineer's Report  
for  
Nettleton Lodge, Brighton  
Brighton & Hove City Council

Issue Number 01  
4 July 2019

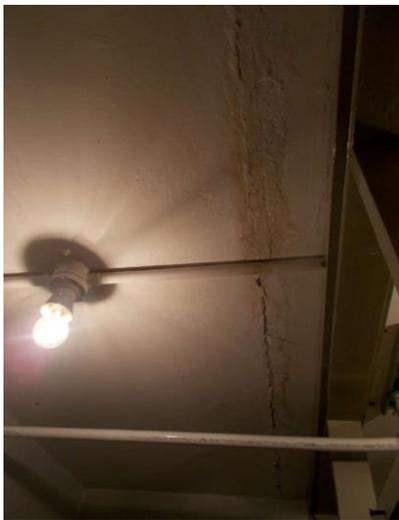
**Photo No. INT-28**

Location	Building Element	Element Description	Condition / Defect	Recommended Works	Photo Number	Rec Year Of Work
Ground Floor Level Caretakers Room	Floor	Precast reinforced concrete slab panels.	Joint between panels filled with mortar. Appears that this may be coming loose.	Rake out and refill the joint with a proprietary concrete repair in accordance with manufacturer's specification.	INT-24	2020
Electricity Intake Room	Walls	Precast Concrete Wall	Slight vertical crack at joints of precast concrete wall panels in South East corner of room. The damage is considered to be due to slight thermal expansions and contractions between the wall sections. This damage is not considered structurally significant.	Visually monitor as part of future routine inspections.	INT-26	2024
Ground Floor Level WC	Internal Ceiling	Precast Reinforced Concrete Slab	Very slight crack in ceiling at joint in floor slab. The damage is considered to be due to slight thermal expansions and contractions between the slab sections. This is not considered to be of structural significance.	Visually monitor as part of future routine inspections.	INT-28	2024

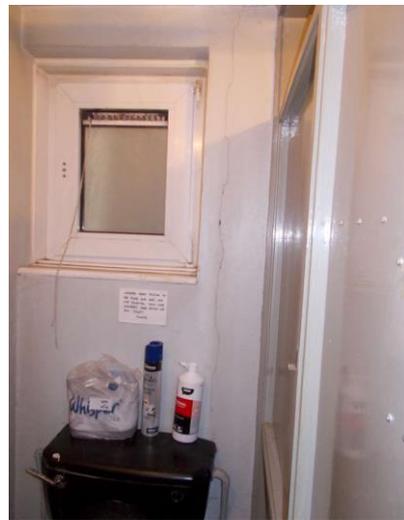
**Photo No. INT-29**

Ground Floor Level WC	Walls	Precast reinforced concrete panels	Very slight vertical crack at joints of precast concrete wall panels to East wall. The damage is considered to be due to slight thermal expansions and contractions between the wall sections. This damage is not considered structurally significant.	Visually monitor as part of future routine inspections.	INT-29	2024

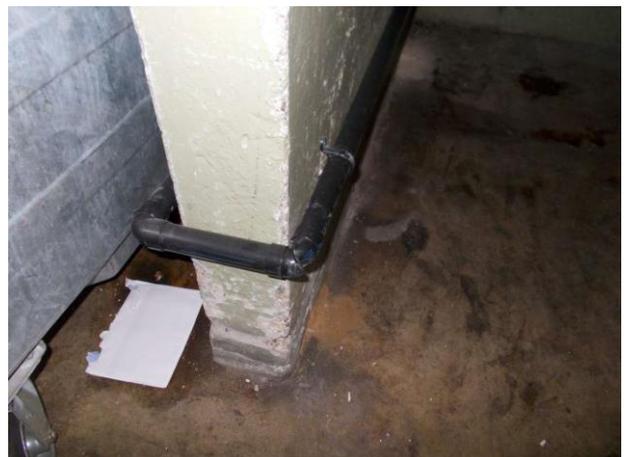
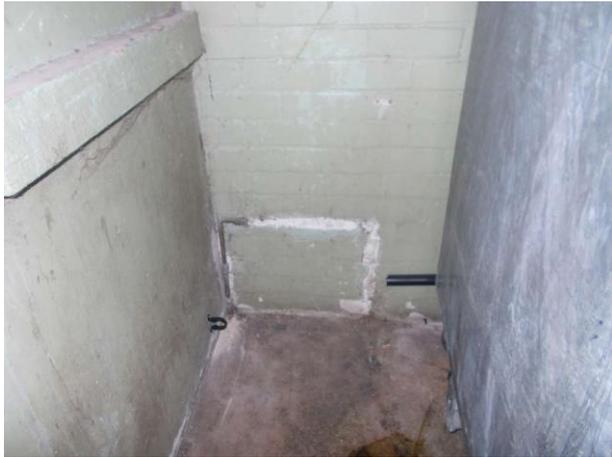
Location	Building Element	Element Description	Condition / Defect	Recommended Works	Photo Number	Rec Year Of Work
Refuse Room	Internal Ceiling	Precast Reinforced Concrete Slab	Various very slight cracks in ceiling at joints between floor slabs. The damage is considered to be due to slight thermal expansions and contractions between the slab sections. This is not considered to be of structural significance.	Visually monitor as part of future routine inspections.	INT-34	2024
Refuse Room	Services	Water Waste Pipe	Although not of direct structural concern, it was observed that a plastic water overflow pipe that runs around the Eastern walls of the room has been fractured following impact from the bins and is missing near its outlet end. Water is therefore leaking onto the floor.	It would be prudent to replace the damaged pipe either with a more robust steel pipe, or to protect a new plastic pipe from impact damage with a metal grill or similar. Constant leaking of water could eventually damage the building structure.	INT-37 / INT-38	2019

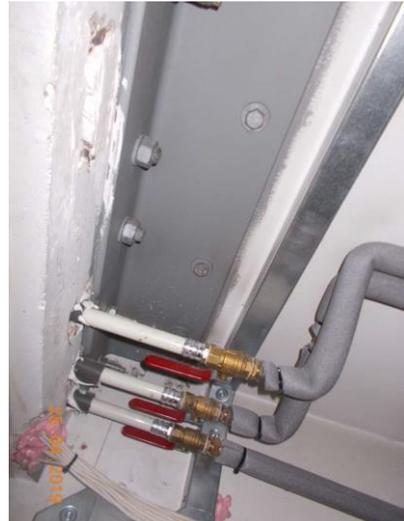
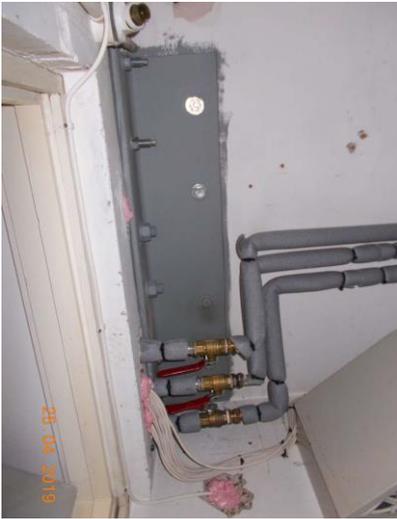
Dry Risers and Risers	Internal Ceiling and Walls	Precast Concrete Walls and Slab	It was observed that within all upper floor Risers and Dry Risers either side of the central Hallways, that steel angle plates had been bolted to the walls between the corridor and risers and the adjacent floor slabs, presumably to act as additional bracing or support for the slab edges at these particular locations.	There did not appear to be any sign of distress in the original construction in these locations or defects with the new steel angles. It would be prudent to review if there are any additional archive records available to ascertain the purpose of these steel angles. In addition, these should be visually monitored as part of future routine inspections.	INT-53/61	2024

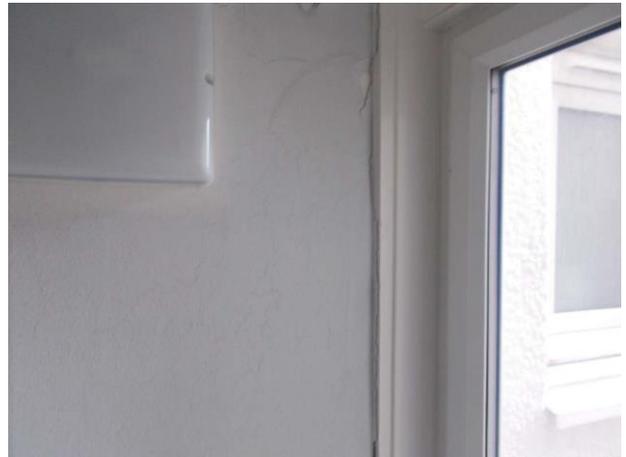
**Photo No. INT-83**

Location	Building Element	Element Description	Condition / Defect	Recommended Works	Photo Number	Rec Year Of Work
Hallways and Stairs Various Floors	Walls	Precast Concrete Wall	Typical hairline to very slight vertical cracks at joints of precast concrete wall panels at various floor levels. The damage is considered to be due to slight thermal expansions and contractions between the wall sections. This damage is not considered structurally significant.	Visually monitor as part of future routine inspections.	INT-81	2024
Hallways to Various Floor Levels adjacent to North and South windows	Walls	Appears to be stud walling	Crazed cracking to plaster finish and hairline cracks at joint between timber window trims and plastic window trims and the wall. The damage is considered to be due to slight thermal expansions and contractions between the different materials. This damage is not considered structurally significant.	Visually monitor as part of future routine inspections.	INT-83	2024

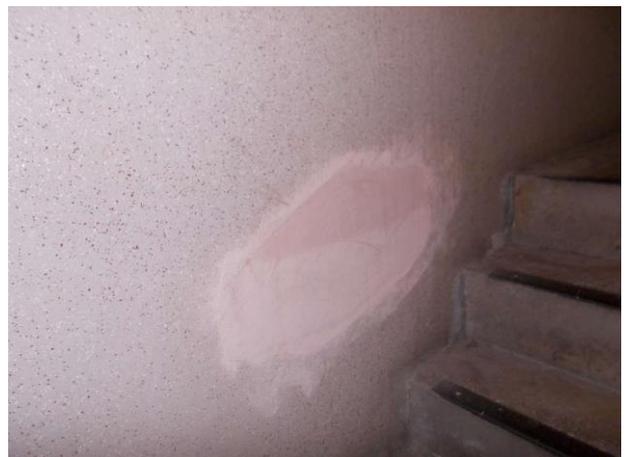
**Photo No. INT-86**

Floor 2 Hallway East wall near North end	Walls	Precast Concrete Wall	Appears to be historic water staining.	It would be prudent to carry out localised repair to the plaster and decorations and then monitor this area as part of future routine inspections.	INT-84	2024
Stairs, 3 <sup>rd</sup> floor level	Walls	Precast Concrete Wall	Patch repair observed at the level of the 3 <sup>rd</sup> floor slab. This could be a location of previous investigations or remedial strengthening repairs.	There did not appear to be any sign of distress in the repair. It would be prudent to review if there are any additional archive records available to ascertain the details of the repair and any possible investigation works undertaken. In addition, this should be visually monitored as part of future routine inspections.	INT-86	2020

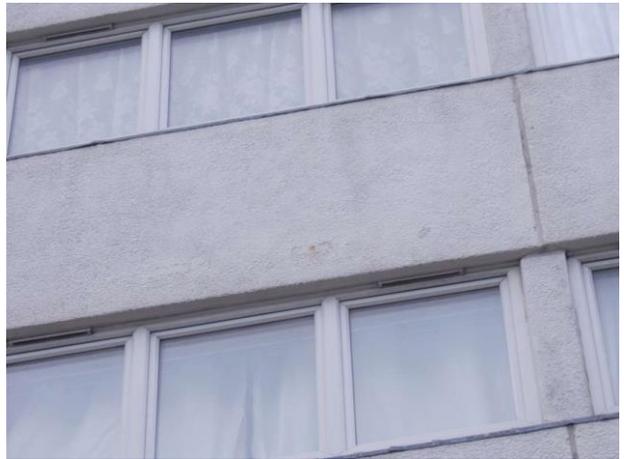
**Photo No. EXT-106**

West External Elevation ██████████ █	Walls	Pre-cast concrete non-loadbearing external panels below windows	Localised spot corrosion to wall panel	Visually monitor as part of future routine inspections.	EXT-106	2024

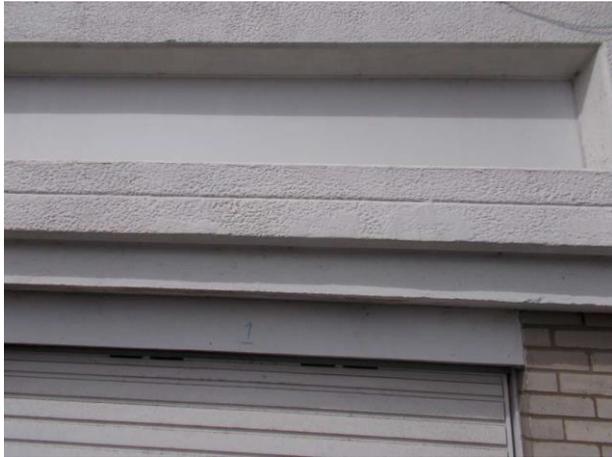
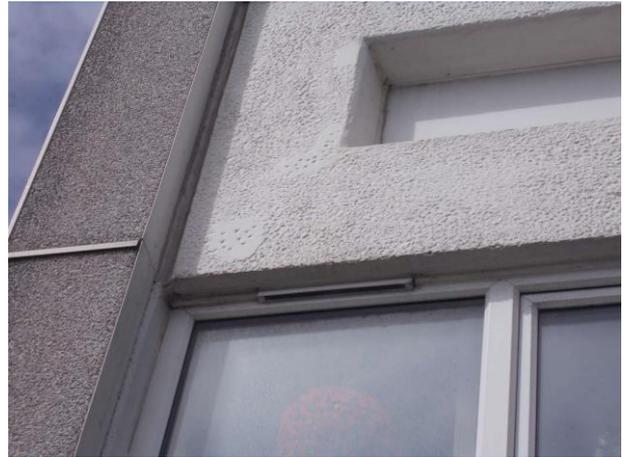
External East Elevation	Walls	Pre-cast concrete non-loadbearing external panels below windows and perpendicular loadbearing walls	Various localised concrete patch repairs to panels across the elevation and to ends of perpendicular loadbearing walls. These repairs all appear to be in satisfactory condition at present.	Visually monitor as part of future routine inspections.	EXT-118 / EXT-119	2024
