PICK EVERARD

Structural Engineer's Report
for
St. James' House, Brighton
Brighton & Hove City Council

Issue Number 01
11 July 2019

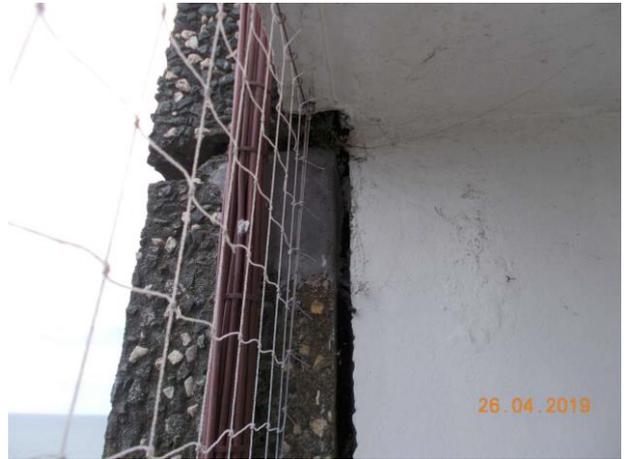
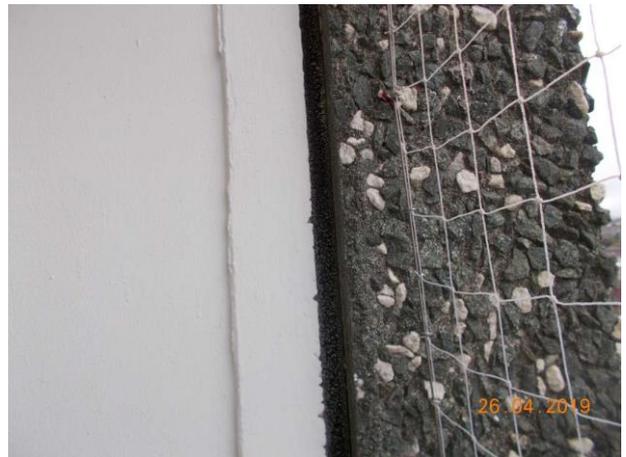
Location	Building Element	Element Description	Condition / Defect	Recommended Works	Photo Number	Rec Year Of Work
Flat ■ Bathroom	Ceiling	Painted artex soffit of precast reinforced concrete plank	Hairline crack to ceiling at slab joint.	Visually monitor as part of future routine inspections.	84	2024
Flat ■ Lounge	Ceiling	Painted artex soffit of precast reinforced concrete plank	Hairline crack to ceiling at slab joint.	Visually monitor as part of future routine inspections.	85	2024
Flat ■ Kitchen	Ceiling	Painted artex soffit of precast reinforced concrete plank	Hairline crack to ceiling at slab joint.	Visually monitor as part of future routine inspections.	86	2024
Flat ■ Balcony Both ends	Wall	Precast concrete wall and end capping	It was observed that there is no sealant to the compressible fill material at what appears to be the joint between the main wall panel and a decorative 'capping' to the end face of the wall.	This appears likely to be a detail repeated at all balcony locations. It would be prudent to seal these joints, subject to the findings of further investigations into the end capping detail and condition of fixings.	87 / 89	2020

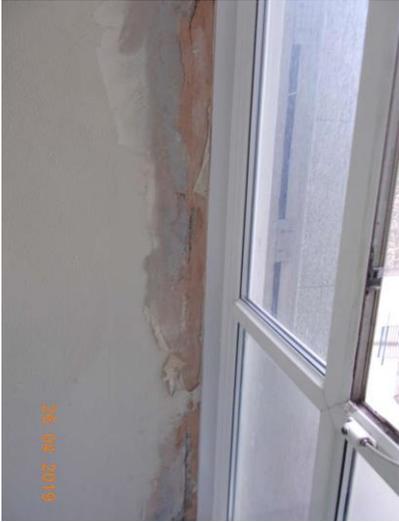
Photo No. 115

Location	Building Element	Element Description	Condition / Defect	Recommended Works	Photo Number	Rec Year Of Work
Flat [REDACTED] Balcony North end	Wall	Precast concrete end capping	Hairline cracking and possible spalling of previous concrete repair to end 'capping' to North side of balcony.	Break out loose concrete and inspect underlying reinforcement for corrosion. Clean any corroded steel reinforcement back to bright metal and apply zinc rich paint followed by proprietary concrete repair in accordance with manufacturer's specification.	88	2020
Internal Central Corridor	Internal wall	Precast concrete wall	Typical hairline to very slight cracks at joints between external wall panels and internal walls of the former Incinerator rooms at each floor level. Extent of visible cracking varies at different floor levels. Some damp damage to plaster as well, likely caused by condensation at the cold bridge adjacent to the external wall.	It would be prudent to make good the cracks by filling with a proprietary concrete repair and make good decorations.	115	2020

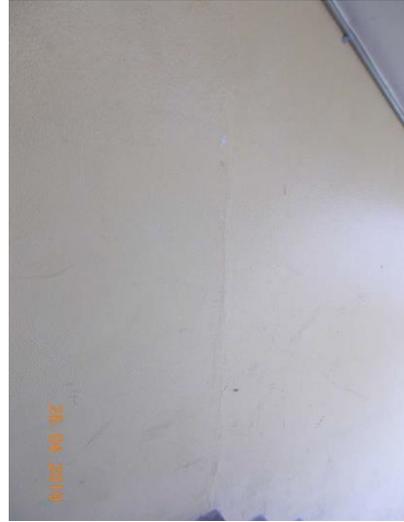
Photo No. 116

Internal staircase walls	Internal wall	Precast concrete wall	Typical hairline vertical crack at joint to internal walls visible. To all staircase levels up the tower.	Visually monitor as part of future routine inspections.	116	2024
Internal staircase windows	Windows	Timber framed internally, double glazed units.	Typical rotting timber to window frame at all floor levels.	Although the damage to the window frame is not a structural concern, water penetration has affected the structure causing corrosion to reinforcement and spalling concrete to the pre-cast stair sections. Therefore it would be prudent to replace the windows to ensure no water ingress into the structure.	118 / 119 / 141	2020

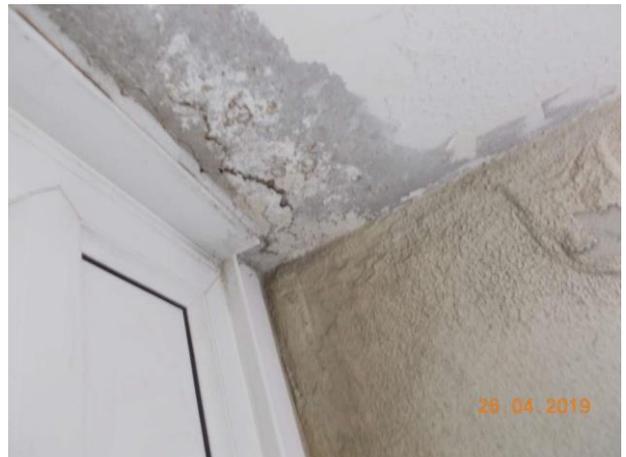
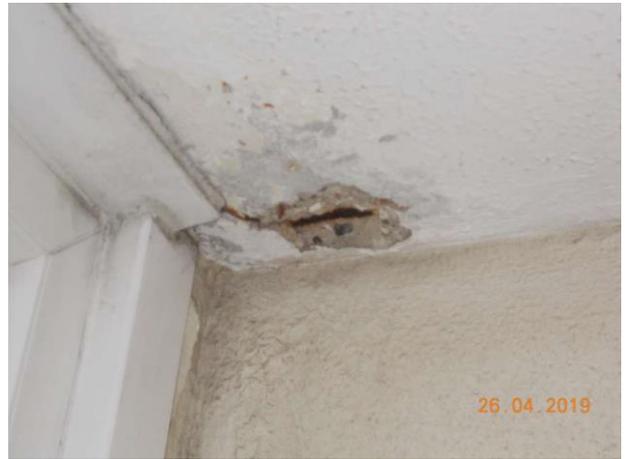
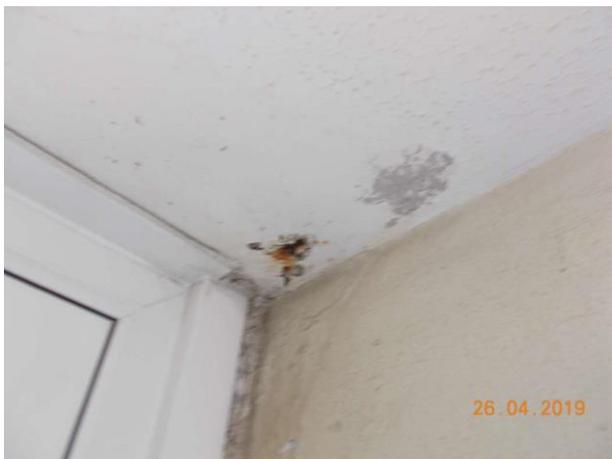
Location	Building Element	Element Description	Condition / Defect	Recommended Works	Photo Number	Rec Year Of Work
Internal Corridor walls	Internal wall	Precast concrete wall	Typical hairline vertical cracks at joints to internal walls visible. To all areas of the building. The damage is considered to be due to slight thermal expansions and contractions between the wall sections. This damage is not considered structurally significant.	Visually monitor as part of future routine inspections.	123	2024
Internal Central Corridor adjacent to the North West windows. Floors 3, 8, 9, 11, 12	Internal ceiling	Precast reinforced concrete slab	Spalling concrete, corrosion staining and spalled concrete and exposed reinforcement to soffit of concrete slab soffit adjacent to the North West windows at various floor levels.	Break out loose concrete and inspect underlying reinforcement for corrosion. Clean any corroded steel reinforcement back to bright metal and apply zinc rich paint followed by proprietary concrete repair in accordance with manufacturer's specification.	125 / 142 / 145	2020

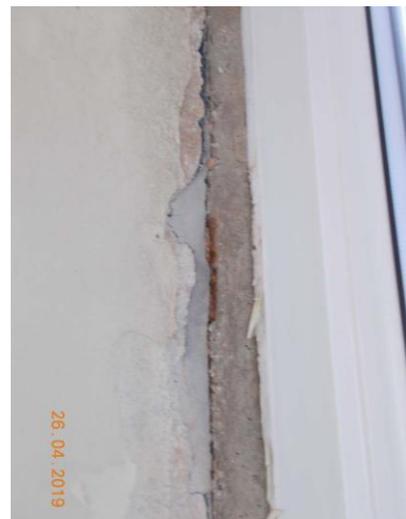
Photo No. 146

Internal Central Corridor adjacent to the North West windows. Floor 11	Wall	Precast concrete wall	Corrosion staining at joint between external wall and internal wall of the former Incinerator room.	Break out surrounding concrete and inspect underlying reinforcement for corrosion. Clean any corroded steel reinforcement back to bright metal and apply zinc rich paint followed by proprietary concrete repair in accordance with manufacturer's specification.	146	2020

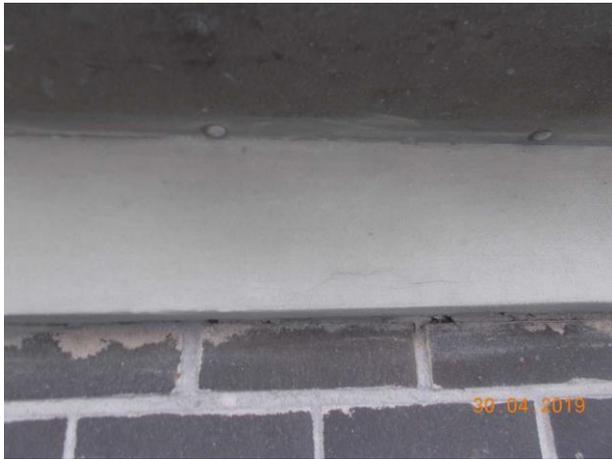
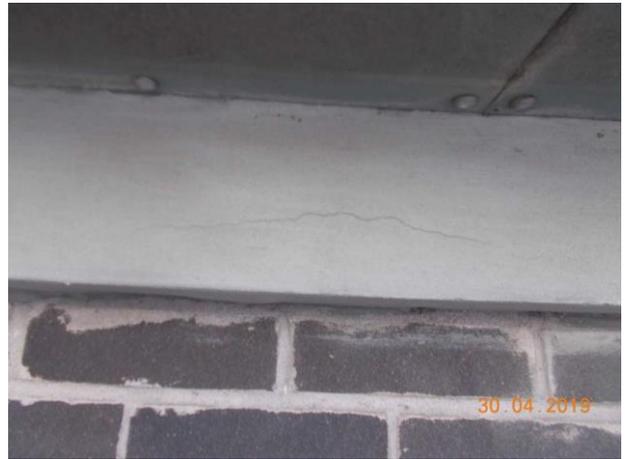
External North Elevation, left end	Beam	In-situ concrete beam	2 no. hairline horizontal cracks in render.	Visually monitor as part of future routine inspections.	171 / 172	2024
External North Elevation, left end	Column	In-situ concrete column	Very slight vertical/diagonal crack in render.	It would be prudent to break off the render at this location to establish if there is any cracking in the underlying concrete structure.	173	2020

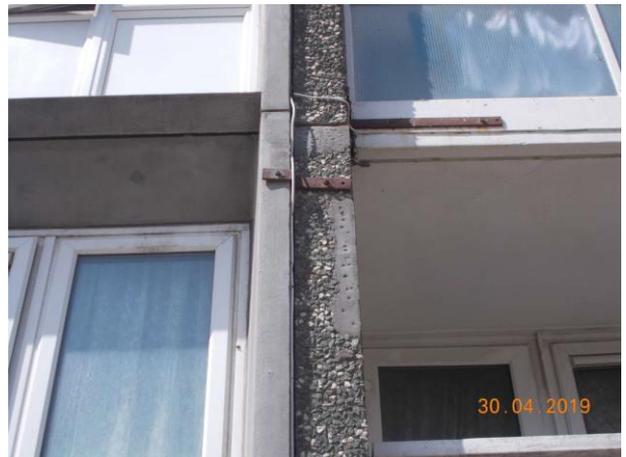
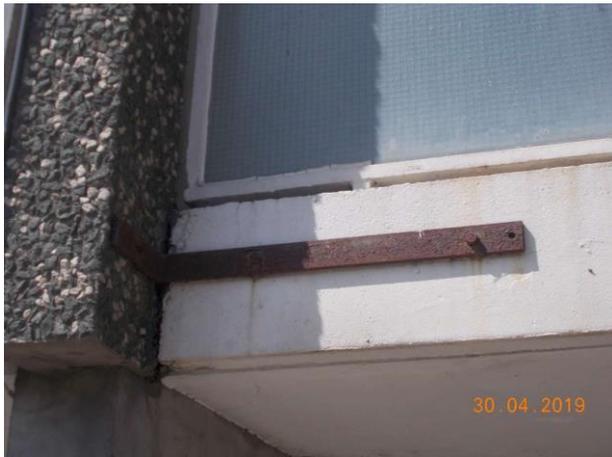
Location	Building Element	Element Description	Condition / Defect	Recommended Works	Photo Number	Rec Year Of Work
External East Elevation ██████████ ██████████ ██████████ ██████████ ██████████ ██████████ (Flat █████ inspected on the ██████████)	Wall	Precast concrete wall	Spalling of previous concrete repairs.	It would be prudent to address these areas as soon as possible to prevent the spalling concrete from de-bonding and falling from the building. This will also allow inspection of the underlying reinforcement condition. Break out surrounding concrete and inspect underlying reinforcement for corrosion. Clean any corroded steel reinforcement back to bright metal and apply zinc rich paint followed by proprietary concrete repair in accordance with manufacturer's specification.	236 / 243 / 244 / 247 / 253	2019
External East Elevation, ██████████ Balcony	Precast concrete end capping	Additional steel restraint straps fixed between walls and floor slabs and the concrete end capping	Steel restraint straps and fixings are corroded. It is assumed that these restraint straps are to provide additional support to the concrete end capping detail at first and second floor levels, presumably following concerns that the end capping may not be fully secure.	It would be prudent to investigate the typical original details of the end capping and how this is fixed to the main concrete wall – it may be utilising dowelled connections. The fixings at this particular location should be investigated to confirm their condition. Following this, appropriate repairs can be specified in regards to any further restraint detail that may be considered necessary to replace the current corroding fixings.	180 / 181	2020

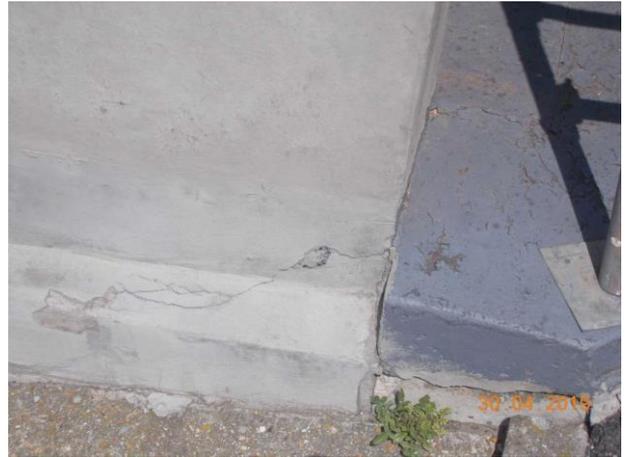
Photo No. 193

Location	Building Element	Element Description	Condition / Defect	Recommended Works	Photo Number	Rec Year Of Work
External South Elevation, ground floor	Wall	Precast concrete wall	Hairline horizontal crack in render finish at joint between beam and infill wall panel below. The damage is considered to be due to slight thermal expansions and contractions between the wall sections. This damage is not considered structurally significant.	Visually monitor as part of future routine inspections.	191	2024
External South Elevation	Wall	Rendered plinth at bottom of wall	Various hairline cracks in render finish which appear to be caused by shrinkage or thermal movements.	Visually monitor as part of future routine inspections.	192	2024
External South-East corner	Column	In-situ concrete column	Hairline diagonal crack in render finish which appears to be caused by shrinkage or thermal movements.	Visually monitor as part of future routine inspections.	193	2024

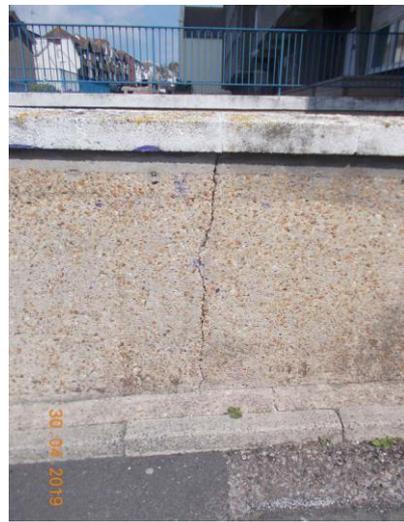
Photo No. 195

Location	Building Element	Element Description	Condition / Defect	Recommended Works	Photo Number	Rec Year Of Work
External South Wall of Western Car Park Ramp	Wall	In-situ, reinforced concrete retaining / freestanding wall	Slight vertical crack in southern wall of western car park ramp. Spalling and exposed corroded reinforcement bar on the north side of the wall. Wall is retaining approx. 1m height of pavement and appears plumb. It appears that the damage is longstanding and due to thermal movements.	Whereas forming a full movement joint may be the more robust solution, the crack has in effect formed a joint in the wall. It could therefore be attempted to remove and loose concrete and saw cut a 20mm wide joint along the line of the crack, 20mm deep each side of the wall and seal with a polyurethane sealant. Followed by making good of any exposed reinforcement by cleaning and application of a zinc rich paint, followed by proprietary concrete repair in accordance with manufacturer's specification. This should be visually monitored as part of future routine inspections. If further damage were to occur, a full movement joint may need to be designed and formed.	195 / 196	2020

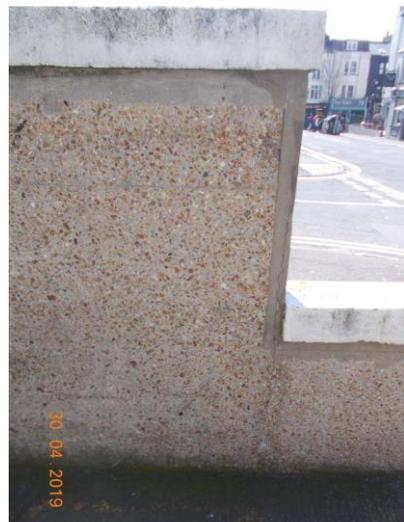
Photo No. 197

External South Wall of Western Car Park Ramp	Wall	In-situ concrete	Very slight vertical and diagonal cracking in concrete and render repairs.	Visually monitor as part of future routine inspections.	197	2024
External West Elevation ██████ ██████████	Beam	In-situ concrete	Localised corrosion staining spot to rendered finish, possibly due to localised corroding reinforcement at shallow depth.	Visually monitor as part of future routine inspections.	198	2024

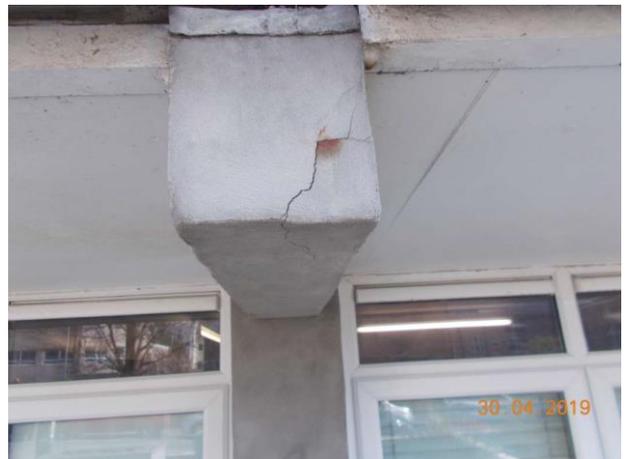
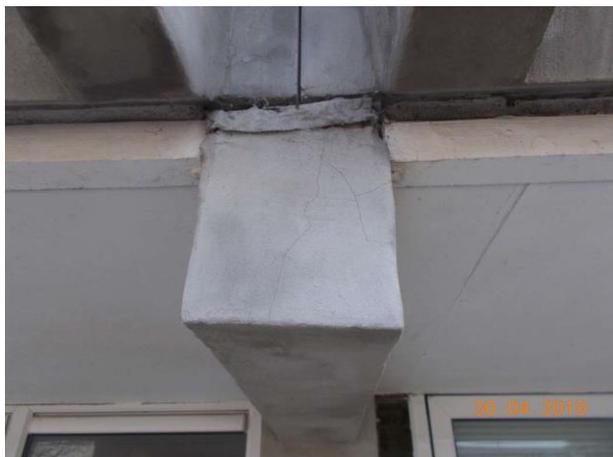
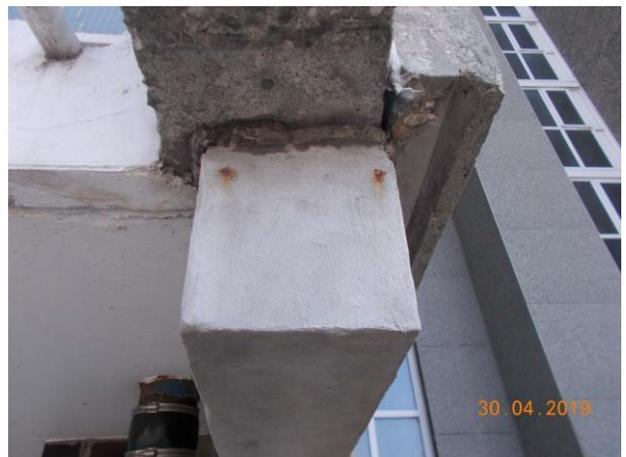
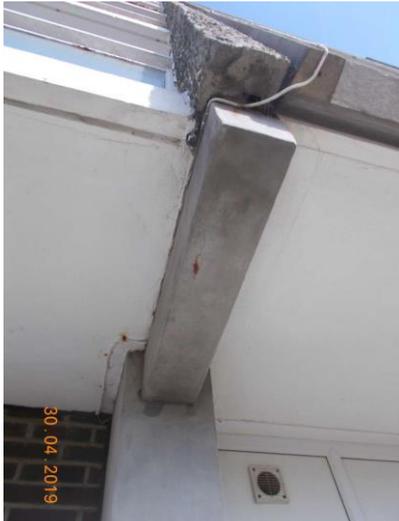
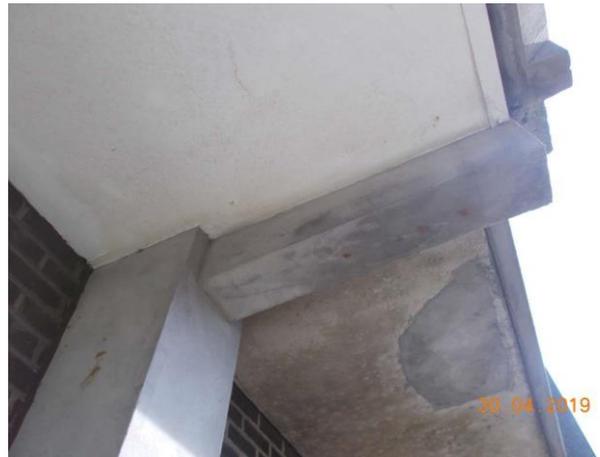
Location	Building Element	Element Description	Condition / Defect	Recommended Works	Photo Number	Rec Year Of Work
External West Elevation ██████ ██████████	Wall	Render finish to masonry wall	Very slight diagonal crack in render finish. This appears likely to be caused by thermal movements.	Visually monitor as part of future routine inspections.	199	2024
External West Elevation ██████████ ██████	Floor	Precast reinforced concrete slab	Localised corrosion staining spot to underside of balcony slab	Visually monitor as part of future routine inspections.	200	2024
External West Elevation cantilevered beam ends at ground floor level: ██████████ ██████████ ██████████ ██████████ ██████ ██████ ██████ ██████████	Beam	In-situ concrete beam	Slight vertical cracking at ends of beams in render and/or corrosion staining.	It would be prudent to break off the render at these locations to establish if there is any cracking/spalling and corroded reinforcement in the underlying concrete structure which may require repair.	201 / 202 / 203 / 268 / 273	2020

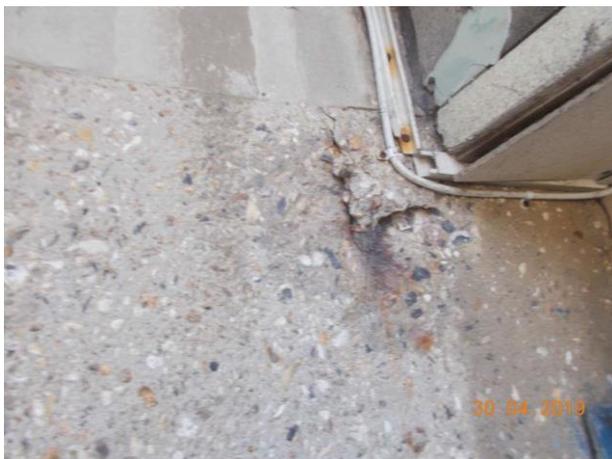
Photo No. 208

External West Elevation Alcove West Facing Wall, ground floor	Wall	Appears to be in-situ concrete wall	Spalling concrete and exposed corroding reinforcement.	Break out loose concrete. Clean any corroded steel reinforcement back to bright metal and apply zinc rich paint followed by proprietary concrete repair in accordance with manufacturer's specification.	208	2020

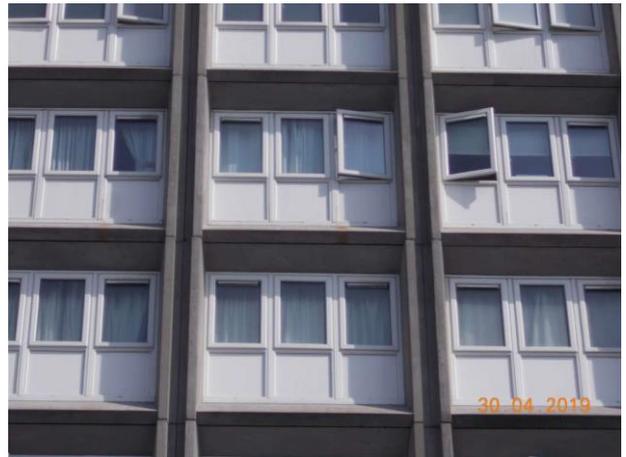
Photo No. 217

Generally to West External Elevation	Walls	Precast concrete wall	Localised corrosion staining to some wall panels.	Visually monitor as part of future routine inspections.	217	2024
Generally to West External Elevation	Walls	Precast concrete wall above windows	Typical pattern of what appears to be 4 no. repaired/filled holes in concrete above window.	Visually monitor as part of future routine inspections.	222	2024

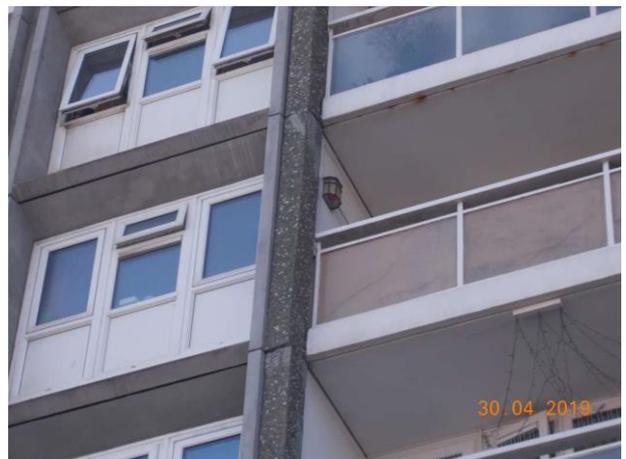
Photo No. 235

East External Elevation [REDACTED] [REDACTED]	Wall to balcony	Precast concrete wall	End capping to wall appears to be slightly distorted.	It would be prudent to investigate the typical original details of the end capping and how this is fixed to the main concrete wall – it may be utilising dowelled connections. The fixings at this particular location should be investigated to confirm their condition. Following this, appropriate repairs can be specified in regards to any further restraint detail that may be considered necessary.	235	2019

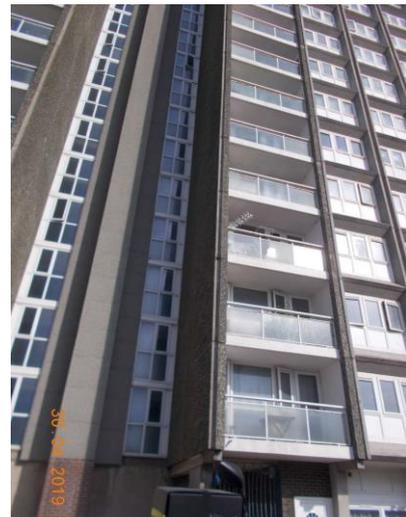
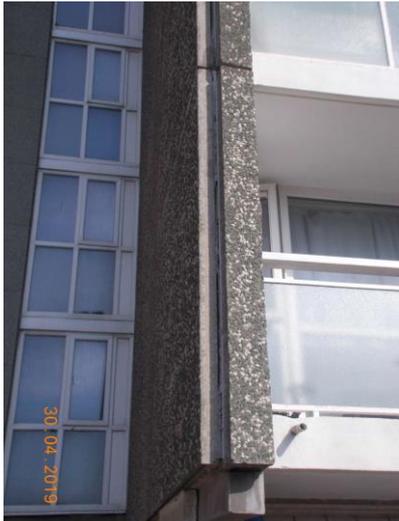
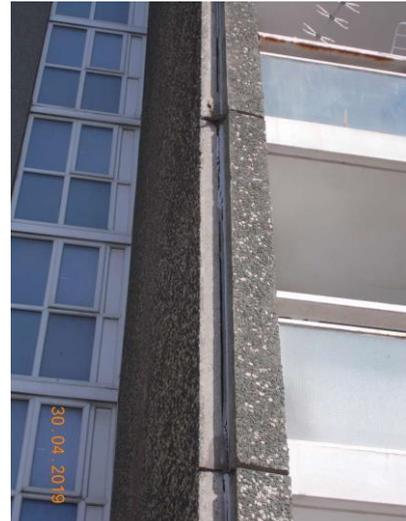
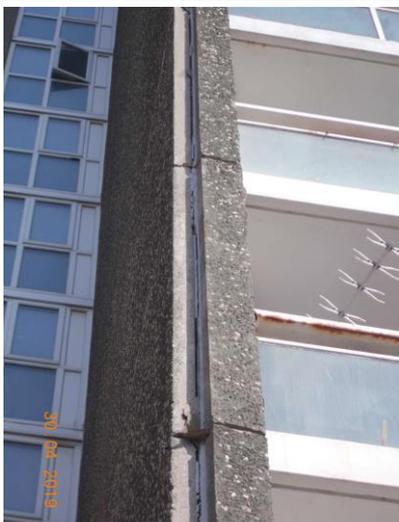
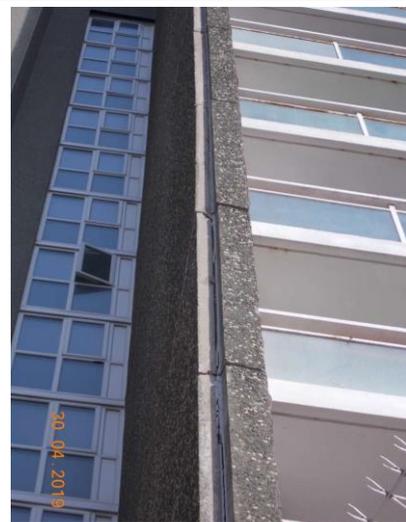
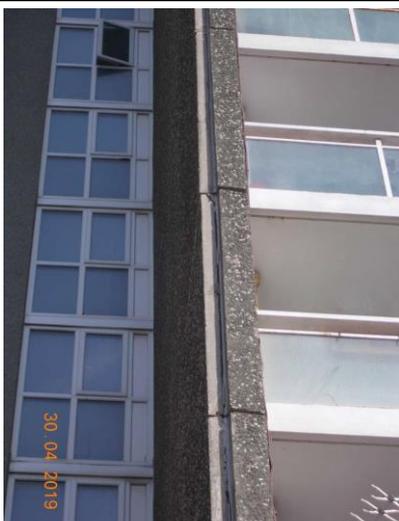
However, there were some localised areas of concern in regards to what appears to be concrete end capping sections fixed to the main pre-cast concrete walls, at the corners of balconies. These were observed to be distorted in a few locations. (Typical example shown in photos 257-262)

Location	Building Element	Element Description	Condition / Defect	Recommended Works	Photo Number	Rec Year Of Work
West External Elevation Balcony Slab soffit, [REDACTED]	Floor	Precast Reinforced concrete	Typical localised corrosion staining and possible spalling concrete. Difficult to see from ground level and through balcony netting to some balconies.	Inspect more closely from balconies of Flats. Potentially repair may involve breaking out surrounding concrete. Clean any corroded steel reinforcement back to bright metal and apply zinc rich paint followed by proprietary concrete repair in accordance with manufacturer's specification.	227	2020
West External Elevation [REDACTED]	Walls	Precast concrete wall	Appears that original end capping concrete is displaced, with cracks/gaps present in the sealant and localised spalling/cracking in the main wall panels at their ends, at 3 rd and 4 th floor levels. It appears likely that reinforcing bar, possibly a doweled connection is corroding and expanding, causing the distortion and cracking.	It would be prudent to fence off a 5m perimeter around this area immediately as some loose parts of the concrete may fall from the building. We then recommend that investigation works are carried out to the end capping to confirm how this is fixed to the main concrete wall. The fixings at this particular location should be investigated to confirm their condition. Following this, appropriate repairs can be specified in regards to any further restraint detail that may be considered necessary.	257-262	2019

- 6.2 However, there were some localised areas of concern in regards to what appears to be concrete end capping sections fixed to the main pre-cast concrete walls, at the corners of balconies. These were observed to be distorted in a few locations. We recommend that these areas are investigated further by metal detector scanning to attempt to locate any connecting dowels and then opening these up locally to inspect the detail and condition. Depth of cover to the reinforcement and carbonation testing should also be undertaken, given the potential for shallower cover at these locations. It was observed that scaffold had been erected at the South East corner of the building (██████) up to the ██████, due to localised concrete spalling in these areas, where concrete has previously fallen to the ground. This scaffold will provide access to carry out further investigations in this area, although it should be confirmed by the scaffold company that it is robust enough for such tasks. In addition it would be prudent to specifically investigate similar details at the North East corner (██████) of the building and on the West elevation to ██████. Repairs to all such areas identified in Section 4.1 can then be recommended and carried out.

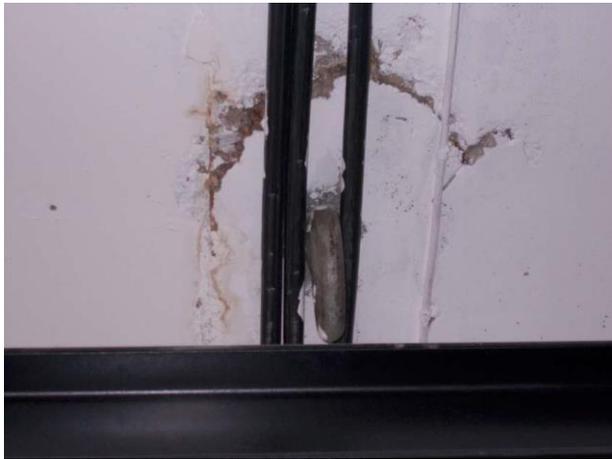
Photo No. ROOF-173

Location	Building Element	Element Description	Condition / Defect	Recommended Works	Photo Number	Rec Year Of Work
West External Elevation [REDACTED] south end of balcony	Wall	Precast concrete wall	Spalling of previous concrete repairs.	It would be prudent to address these areas as soon as possible to prevent the spalling concrete from de-bonding and falling from the building. This will also allow inspection of the underlying reinforcement condition. Break out surrounding concrete and inspect underlying reinforcement for corrosion. Clean any corroded steel reinforcement back to bright metal and apply zinc rich paint followed by proprietary concrete repair in accordance with manufacturer's specification.	266	2019
Lift Motor Room	Ceiling	Precast reinforced concrete slab	Spalling concrete around previous lifting eye fixed into roof soffit.	Break out surrounding concrete and inspect underlying reinforcement for corrosion. Clean any corroded steel reinforcement back to bright metal and apply zinc rich paint followed by proprietary concrete repair in accordance with manufacturer's specification.	ROOF-173	2020

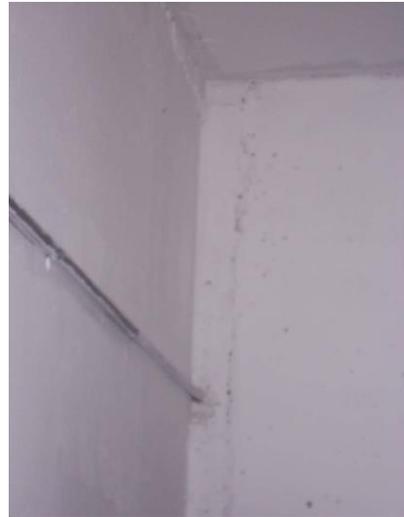
Photo No. ROOF-175

Lift Motor Room	Wall	Precast Concrete Wall	Typical hairline to very slight cracks at joints between wall panels. The damage is considered to be due to slight thermal expansions and contractions between the wall sections. This damage is not considered structurally significant.	Visually monitor as part of future routine inspections.	ROOF-175	2024

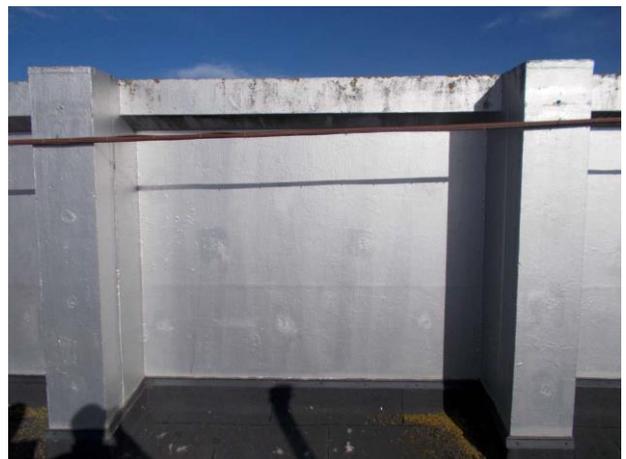
Photo No. ROOF-186

Location	Building Element	Element Description	Condition / Defect	Recommended Works	Photo Number	Rec Year Of Work
Lift Motor Room	Ceiling	Precast reinforced concrete slab	Previous concrete soffit patch repairs	Appear to be good condition, visually monitor as part of future routine inspections.	ROOF-181	2024
Roof parapet wall	Wall	Precast reinforced concrete slab	Appears to be typical patch repairs to internal face of pre-cast concrete parapet wall, staggered vertically and horizontally.	Visually monitor as part of future routine inspections.	ROOF-186	2024
